# HVAC Evaporator Drain Hose Clogged Due to Insect Intrusion

**Service Category** Vehicle Interior

**Section** Heating/Air Conditioning

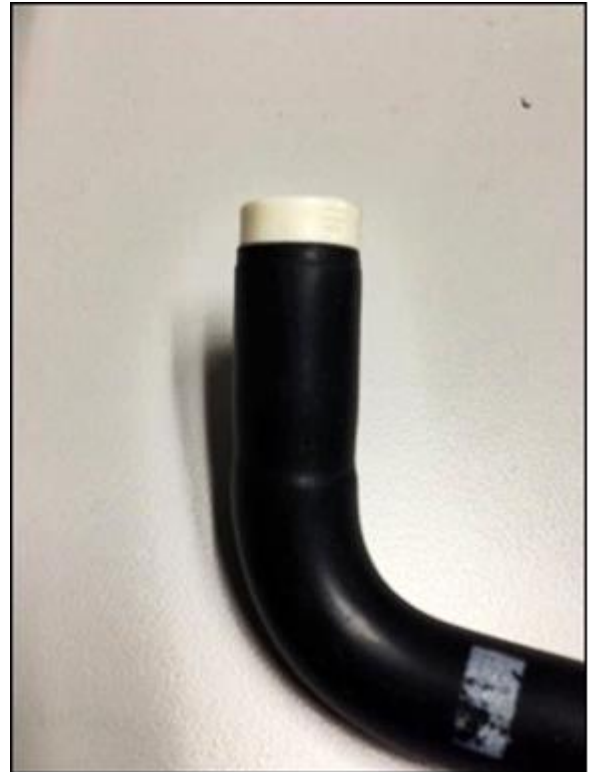
**Figure 1**

1. Follow the instructions provided in the Safety Requirements for Handling the ARINIX® Tip (Water Hose Connector) section of this bulletin.
2. Locate the HVAC evaporator drain hose.
3. Following the vehicle specific Repair Manual, remove the HVAC evaporator drain hose.
4. Put on all necessary PPE and install the ARINIX® Tip (Water Hose Connector) into the NEW HVAC evaporator drain hose listed in the Parts Information section of this bulletin.
5. When installing the ARINIX® Tip, verify it is fully seated in the HVAC evaporator drain hose as shown in Figure 1.
6. Following the vehicle specific Repair Manual, install the HVAC evaporator drain hose.

1. Follow the instructions provided in the Safety Requirements for Handling the ARINIX® Tip (Water Hose Connector) section of this bulletin.
2. Locate the HVAC evaporator drain hose.
3. Following the vehicle specific Repair Manual, remove the HVAC evaporator drain hose.
4. Put on all necessary PPE and install the ARINIX® Tip (Water Hose Connector) into the NEW HVAC evaporator drain hose listed in the Parts Information section of this bulletin.
5. When installing the ARINIX® Tip, verify it is fully seated in the HVAC evaporator drain hose as shown in Figure 1.
6. Following the vehicle specific Repair Manual, install the HVAC evaporator drain hose.

6. When installing the ARINIX® Tip, verify it is fully seated in the HVAC evaporator drain hose as shown in Figure 1.
7. Following the vehicle specific Repair Manual, install the HVAC evaporator drain hose.

1. Follow the instructions provided in the Safety Requirements for Handling the ARINIX® Tip (Water Hose Connector) section of this bulletin.
2. Locate the HVAC evaporator drain hose.
3. Following the vehicle specific Repair Manual, remove the HVAC evaporator drain hose.
4. Before installing the ARINIX® Tip (Water Hose Connector) into the original HVAC evaporator drain hose, the end of the hose **MUST** be cut perpendicular as shown in Figure 2.
5. Put on all necessary PPE and install the ARINIX® Tip into the original HVAC evaporator drain hose listed in the Parts Information section of this bulletin.
6. When installing the ARINIX® Tip, verify it is fully seated in the HVAC evaporator drain hose as shown in Figure 1.
7. Following the vehicle specific Repair Manual, install the HVAC evaporator drain hose.

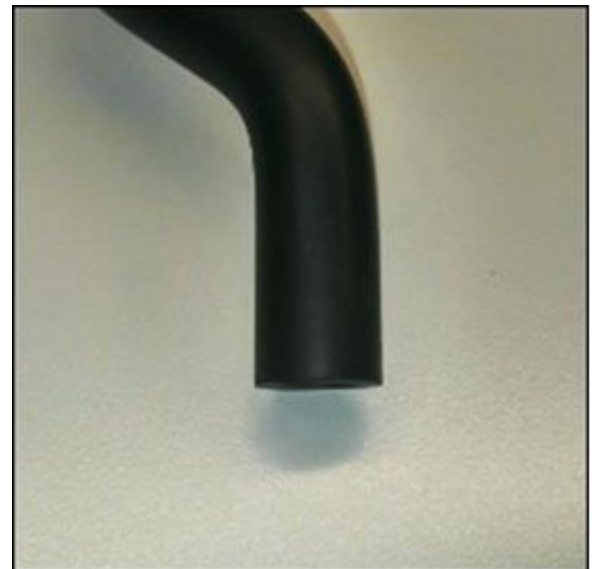
**Figure 2**

1. Follow the instructions provided in the Safety Requirements for Handling the ARINIX® Tip (Water Hose Connector) section of this bulletin.
2. Locate the HVAC evaporator drain hose.
3. Following the vehicle specific Repair Manual, remove the HVAC evaporator drain hose.
4. Before installing the ARINIX® Tip (Water Hose Connector) into the NEW HVAC evaporator drain hose, the end of the hose MUST be cut perpendicular as shown in Figure 2.

5. Put on all necessary PPE and install the ARINIX® Tip into the NEW HVAC evaporator drain hose listed in the Parts Information section of this bulletin.
